GEOTECHNICAL RECONNAISSANCE OF THE 2010 DARFIELD (NEW ZEALAND) EARTHQUAKE

Version 1: 10 November 2010

EDITORS

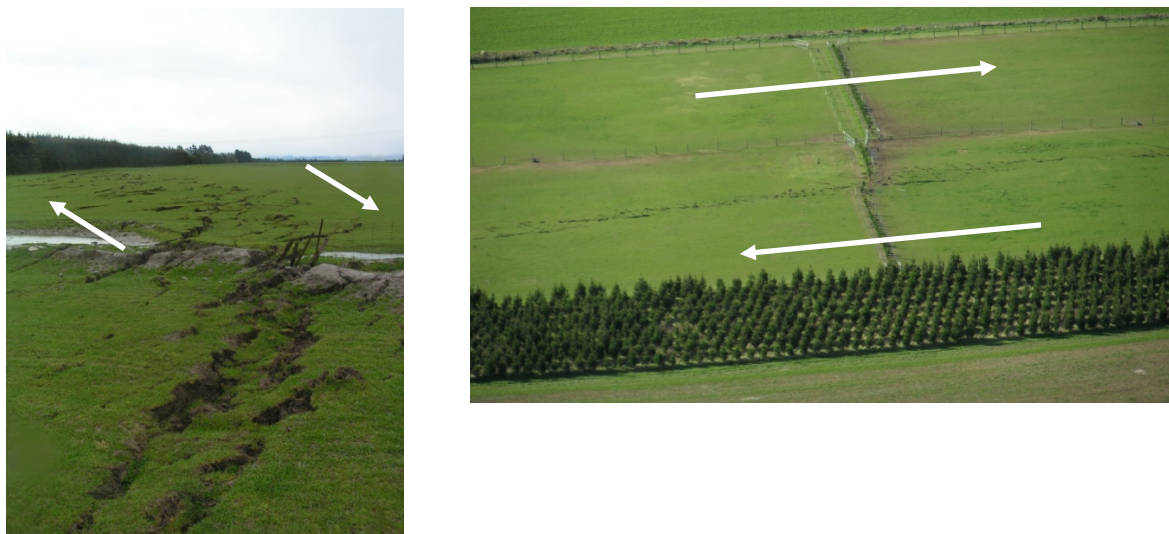
Figure 2.4 Photographs of surface fault rupture on the Greendale fault (left photo: <http://daveslandslideblog.blogspot.com/2010/09/images-of-darfield-canterbury.html>).

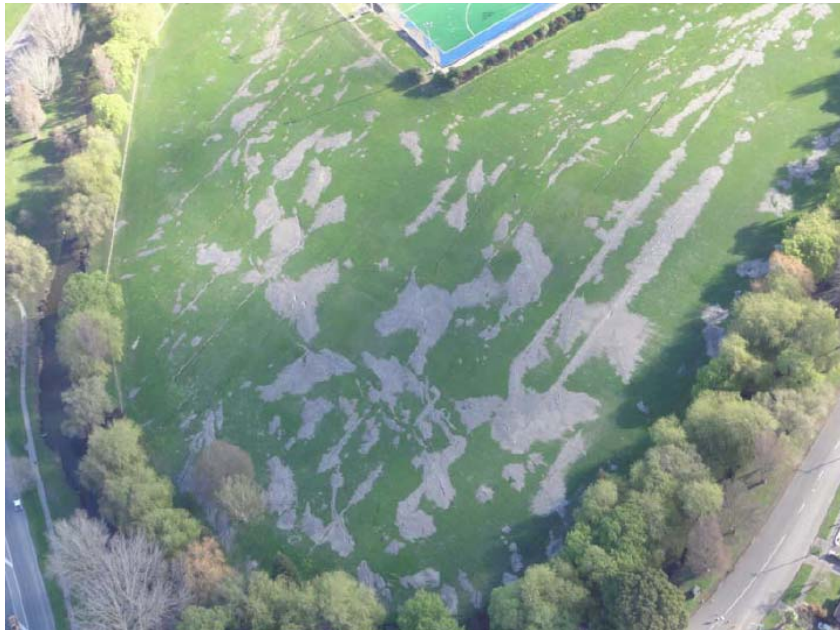
(a) Aerial view: massive sand boils with large number of parallel cracks along drainage lines (from a helicopter flyover on the afternoon of Friday September 10)

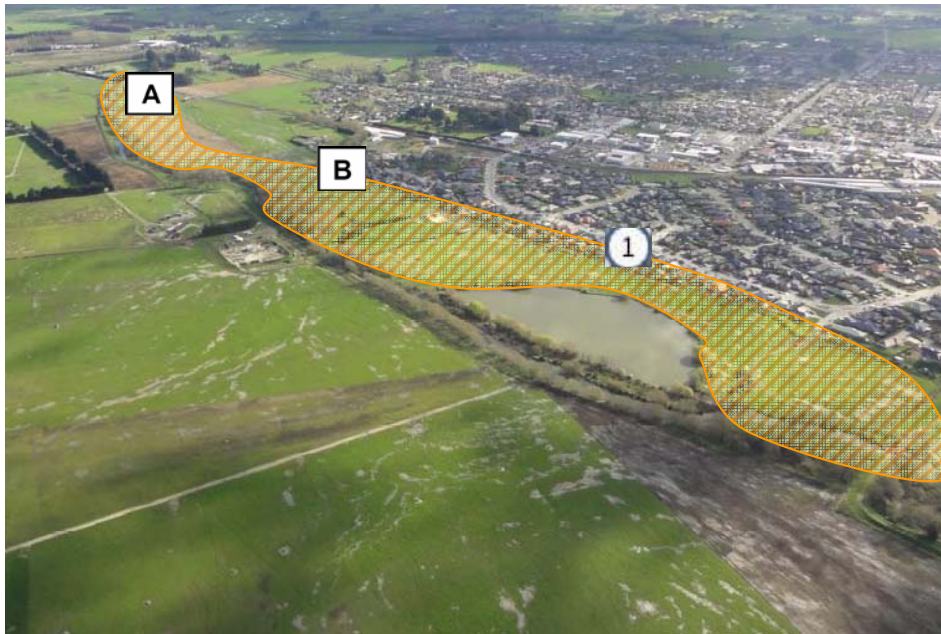
(a) Sand boils and area affected by lateral spreading around Courtenay Lake (from a helicopter flyover on Friday September 10)

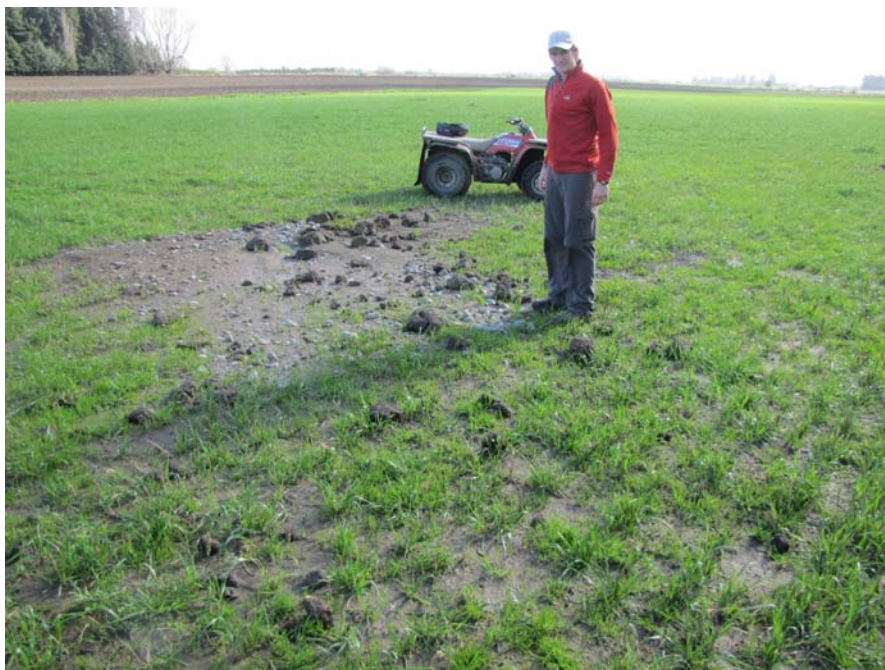
Figure 4.40 Ejected material on another paddock of the Selwyn Forks farm (Sheepyard paddock). As well as sand and gravel the ejecta contain clods of topsoil. (Position marked as Photo 4 in Fig. 4.36.)

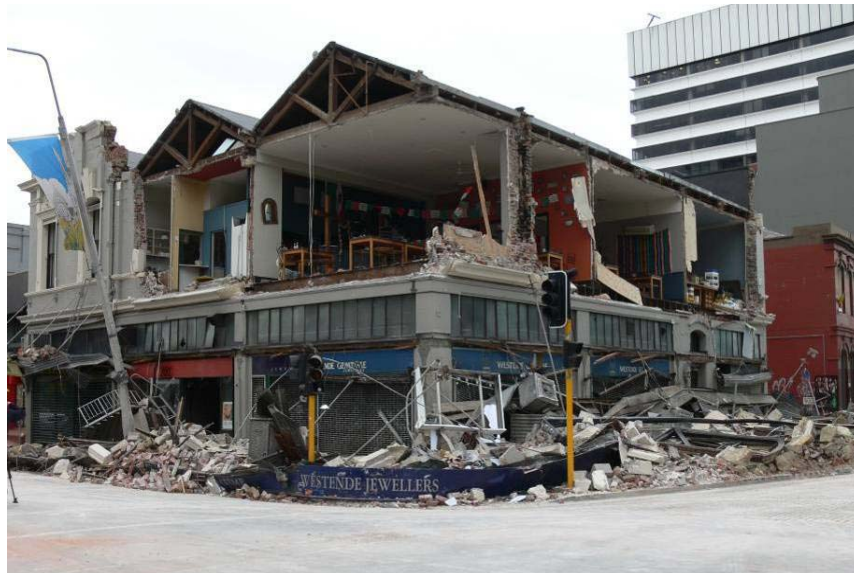
Figure 5.1. Structural collapse of a URM in the Christchurch Business District. (184 Manchester Street). Photograph courtesy of Prof Jason Ingham

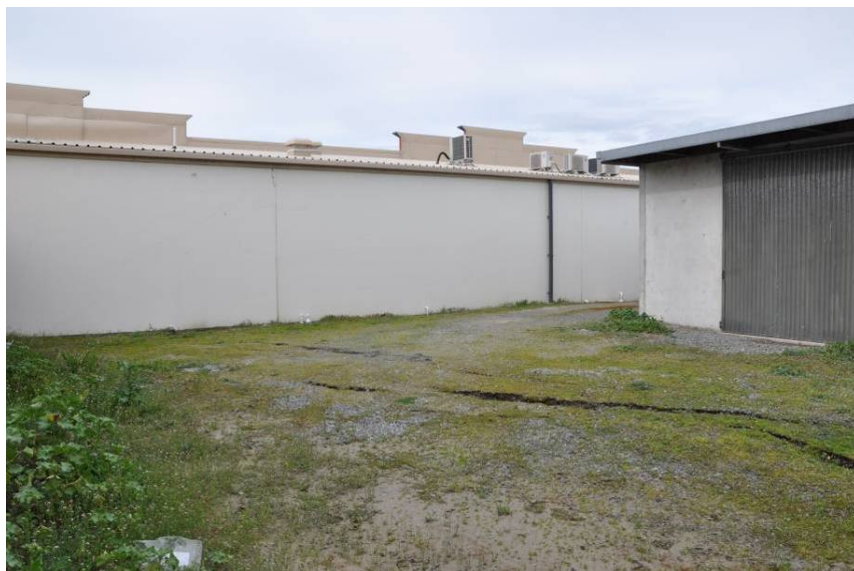
Figure 5.9 Surrounding ground failure patterns directly adjacent to the Property and Family Law Offices in Kaiapoi business district. View looking southeast (1100 hrs on 11 September 2010)

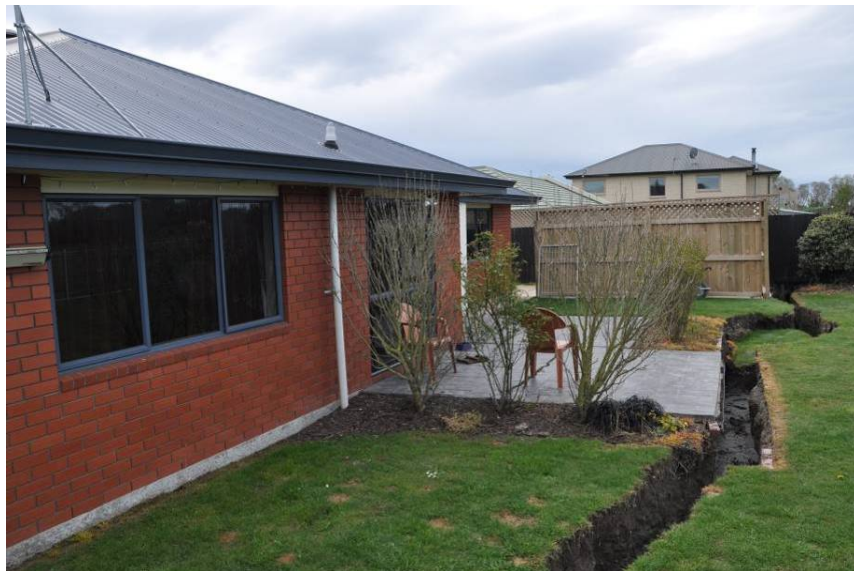
Figure 5.20 Ground failure feature extending through the backyard of a home on the south side of Courtenay Drive in the South Kaiapoi residential community. (1500 hrs on 11 September 2010)

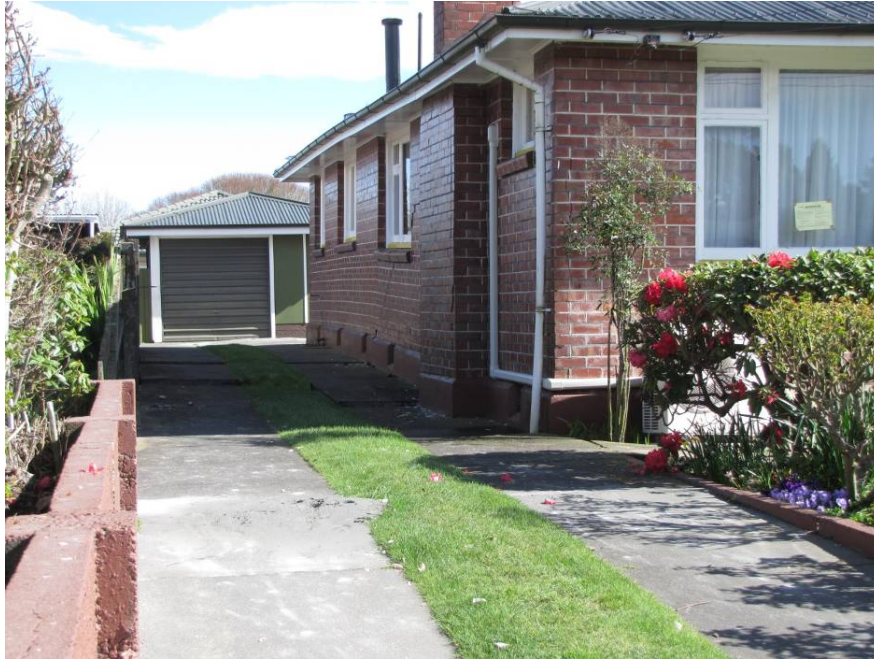
Figure 5.26. Residence affected by lateral spreading along the driveway which has induced differential settlement between the front and rear of the house. (Note that this is not a slab-on-ground house, and older style of construction with a concrete perimeter beam and the timber floor being supported on shallow foundations; Locksley Ave.; 1130 hrs on 14 September 2010)

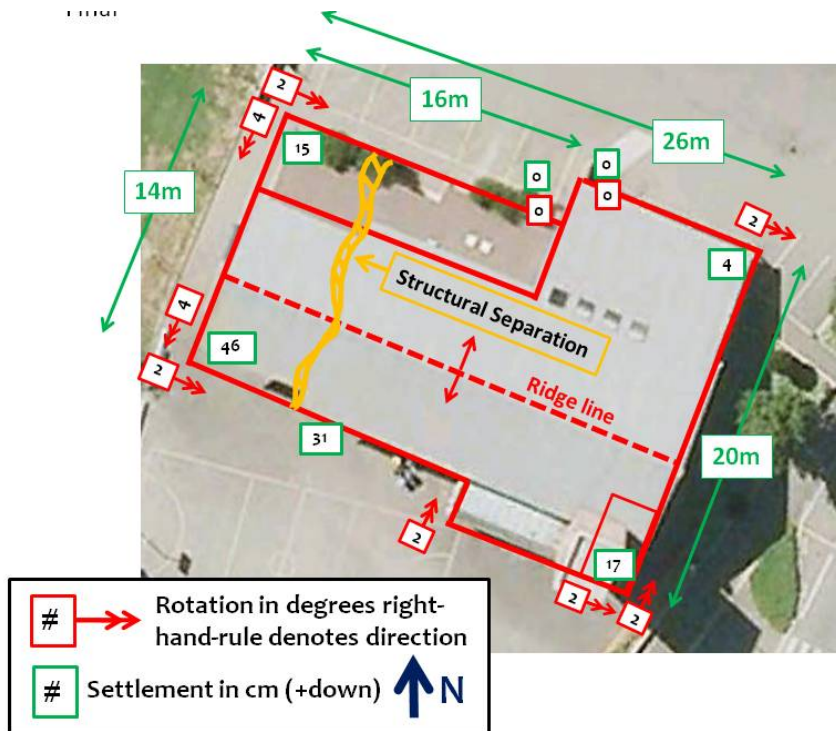
Figure 5.29. St. Paul's church damage map – survey conducted 12 September 2010; Global dimensions approximate (extracted from GoogleEarth image), deformation obtained directly in the field

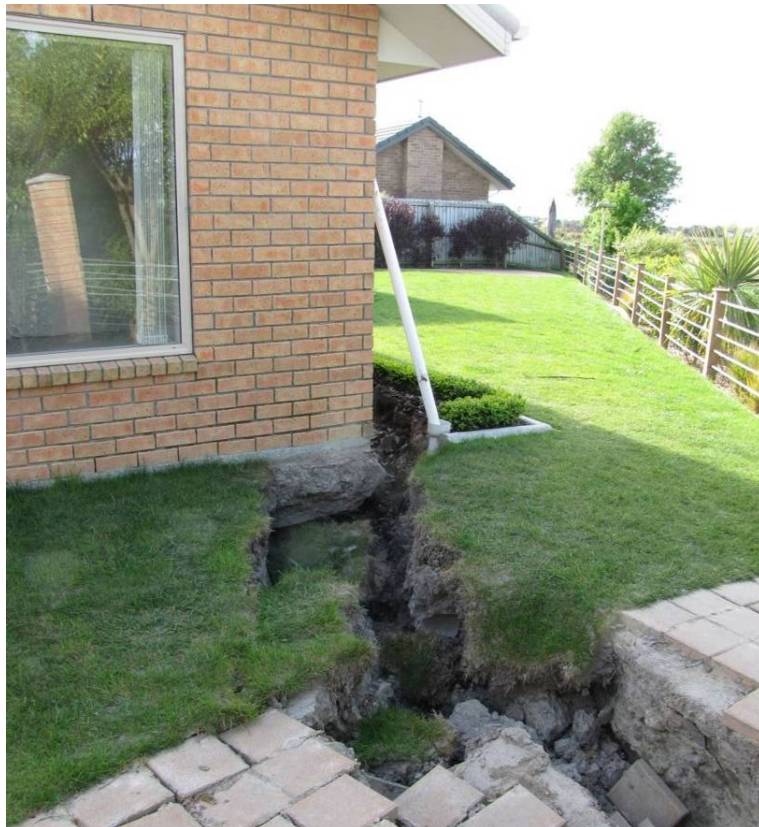
Figure 5.38. Lateral spreading compromising ground support beneath the concrete slab-on-grade house foundation. (Kokopu Street; 1030hrs on 12 September 2010)

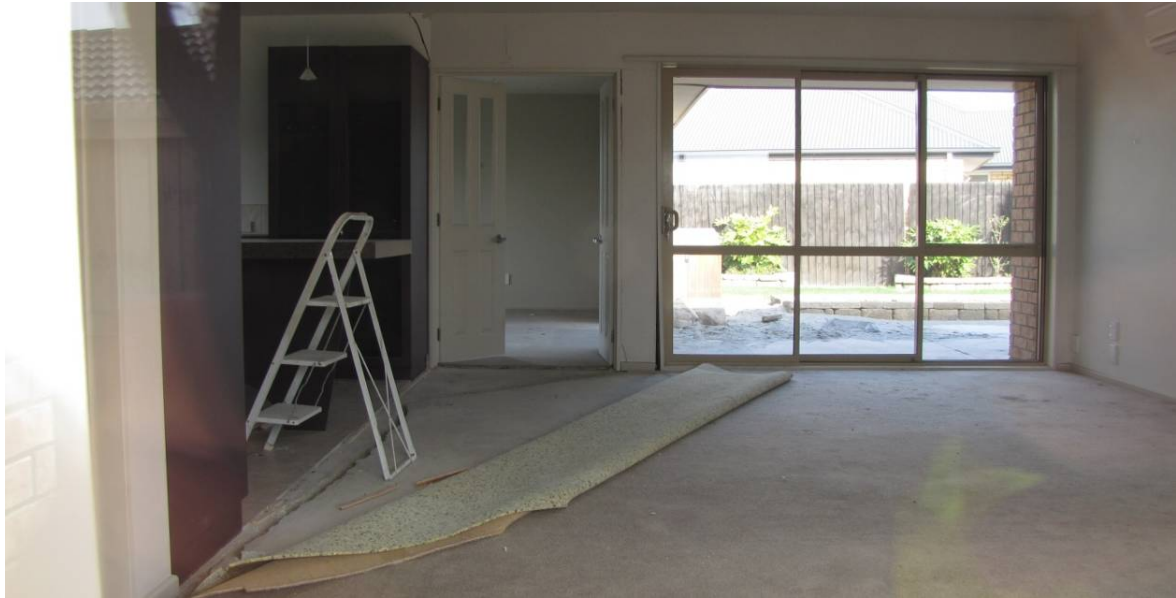
Figure 5.39. Fissure in concrete floor slab (to the left hand side passing beneath the ladder). (Same house as in Figure 5.38.) (Kokopu Street; 1030hrs on 12 September 2010)

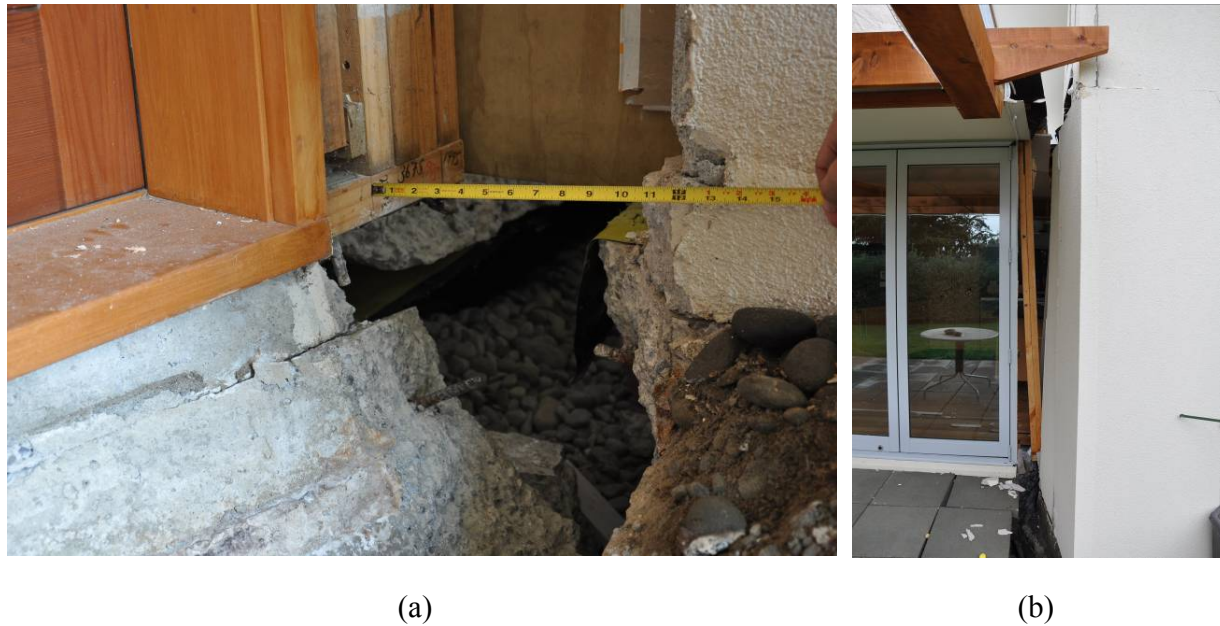
Figure 5.44. Ruptured floor slab near the front entrance of Riverside Lane. Clearly visible is the gravel infill shown in Figure 5.41 (note that there appears to be no ejected sand present). (a) ground fissure separating front entry of home and (b) same ground feature propagated through home and departing on opposing side (1230hrs on 13 September 2010)

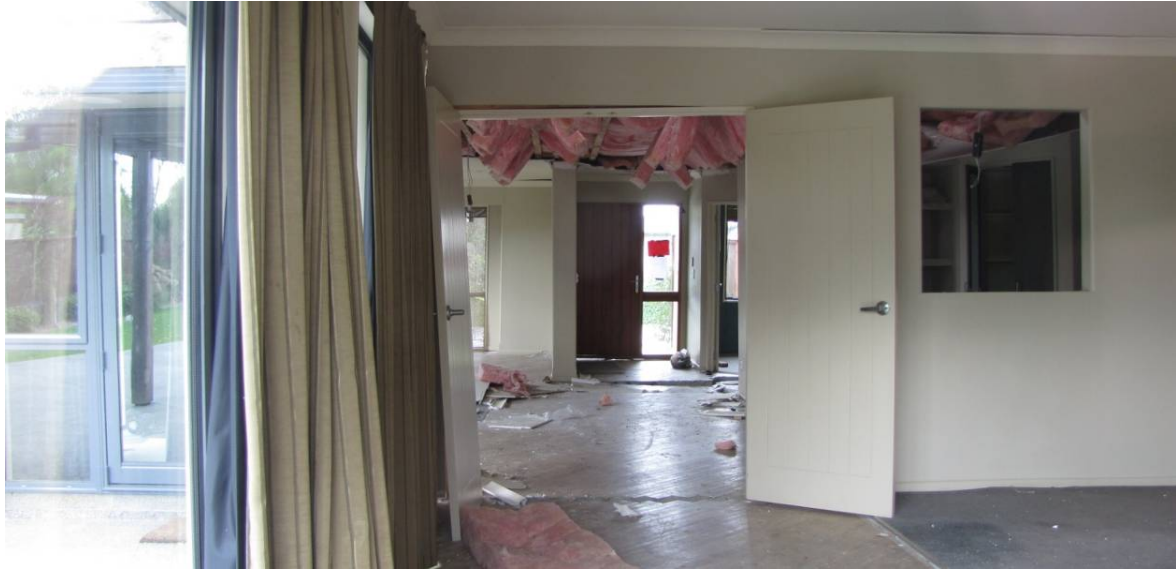
Figure 5.45. Interior view of residence at Riverside Lane. Note the two floor breaks visible in the picture (1500hrs on 28 September 2010)

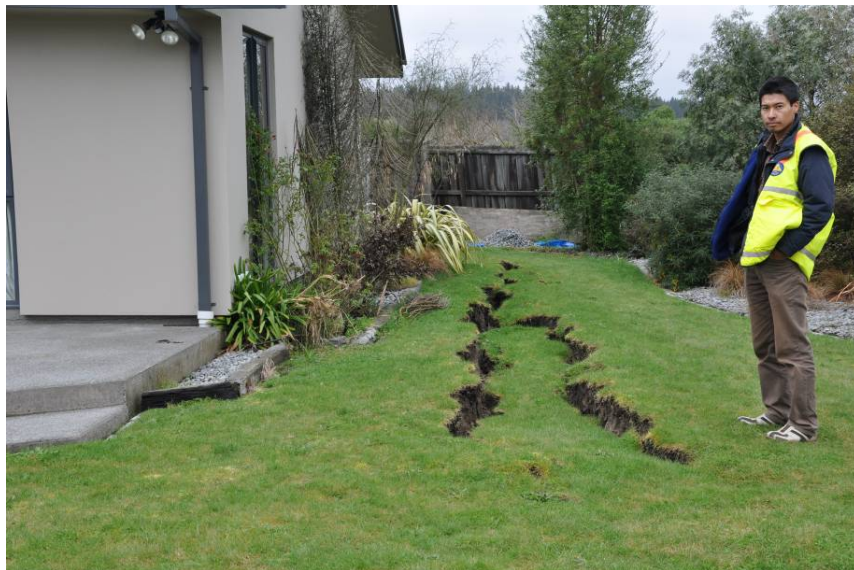
Figure 5.46. Lateral spread adjacent to residence at Riverside Lane. The location of this fissure is about 26 metres from the nearby Styx River. (1230 hrs on 13 September 2010).

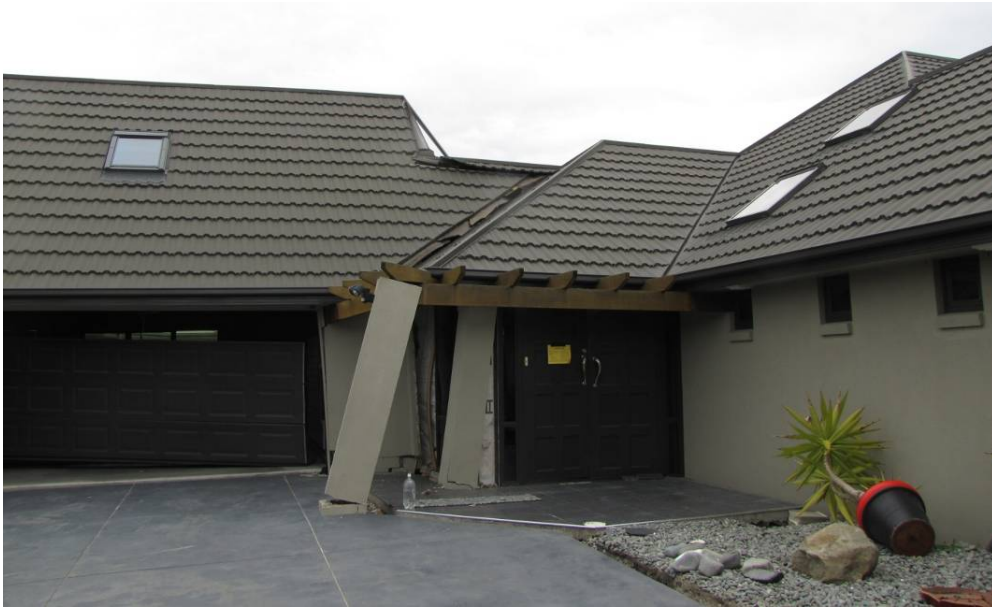
Figure 5.47. House with fissured floor slab with damage carried through to the roof line which is no longer weather proof. (Riverside Lane, Spencerville). (1600hrs on 28 September 2010)

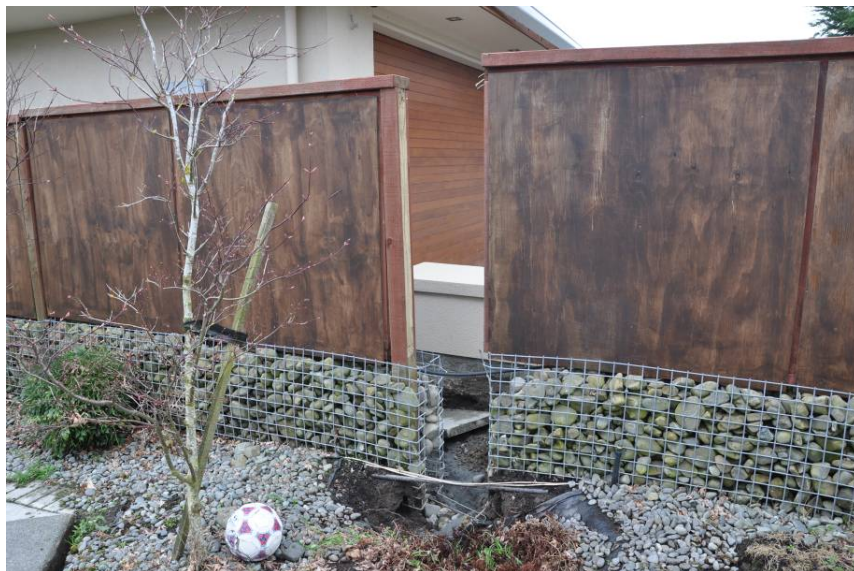
Figure 5.48 Separated fence line due to propagating ground fissure meandering between homes along Riverside Lane. (1230hrs on 13 September 2010)

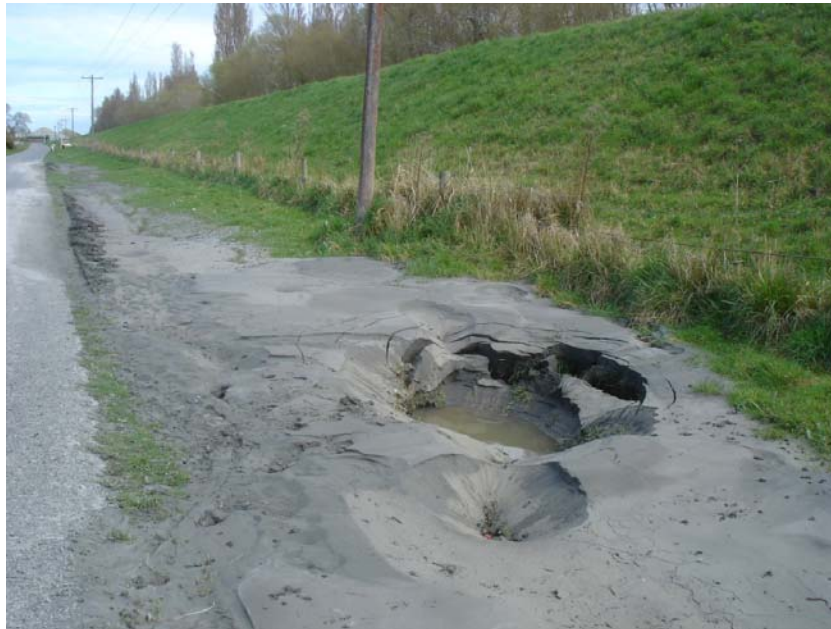
Figure 6.4 Photo 1: Large sand boil at the base of the landside of the stopbank on Coutts Island Rd. (43.425018°S, 172.628442°E)

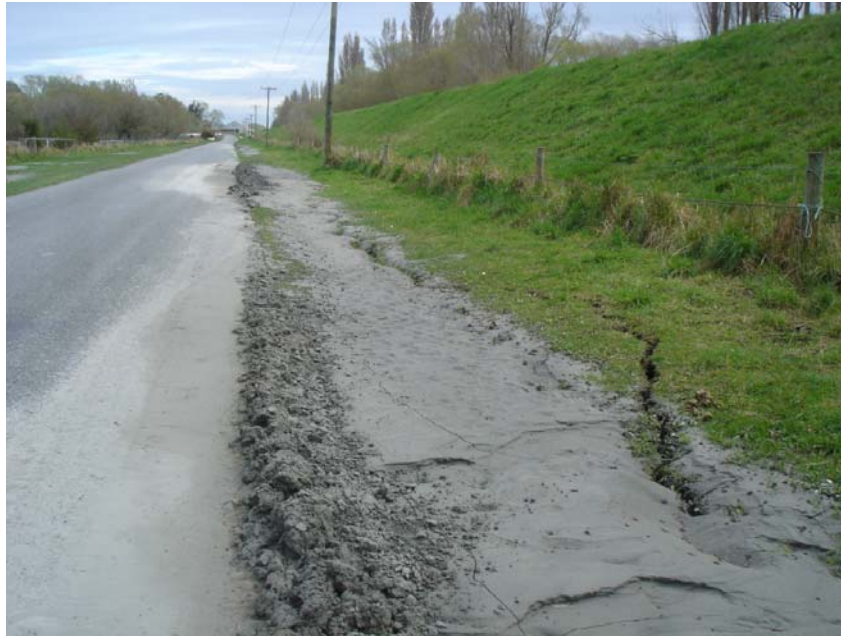
Figure 6.5 Photo 2: Crack running along base of stopbank on Coutts Island Rd (landside) and liquefaction ejecta. (43.424466°S, 172.629907°E)

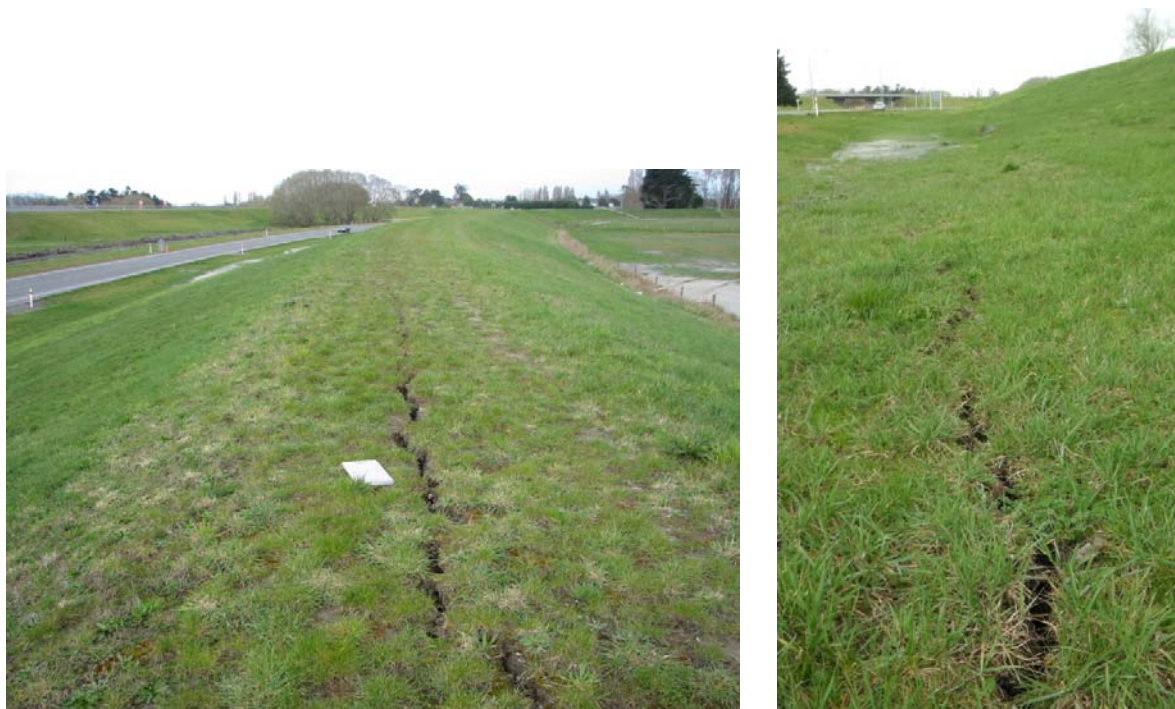
Figure 6.15 Photos 9 and 10: ~5-cm wide longitudinal cracks running along the crest (left) and base (right) of a secondary stopbank for the Waimakariri River. Photo taken looking southwest; SH1 on left of stopbank (43.430108°S, 172.643434°E)

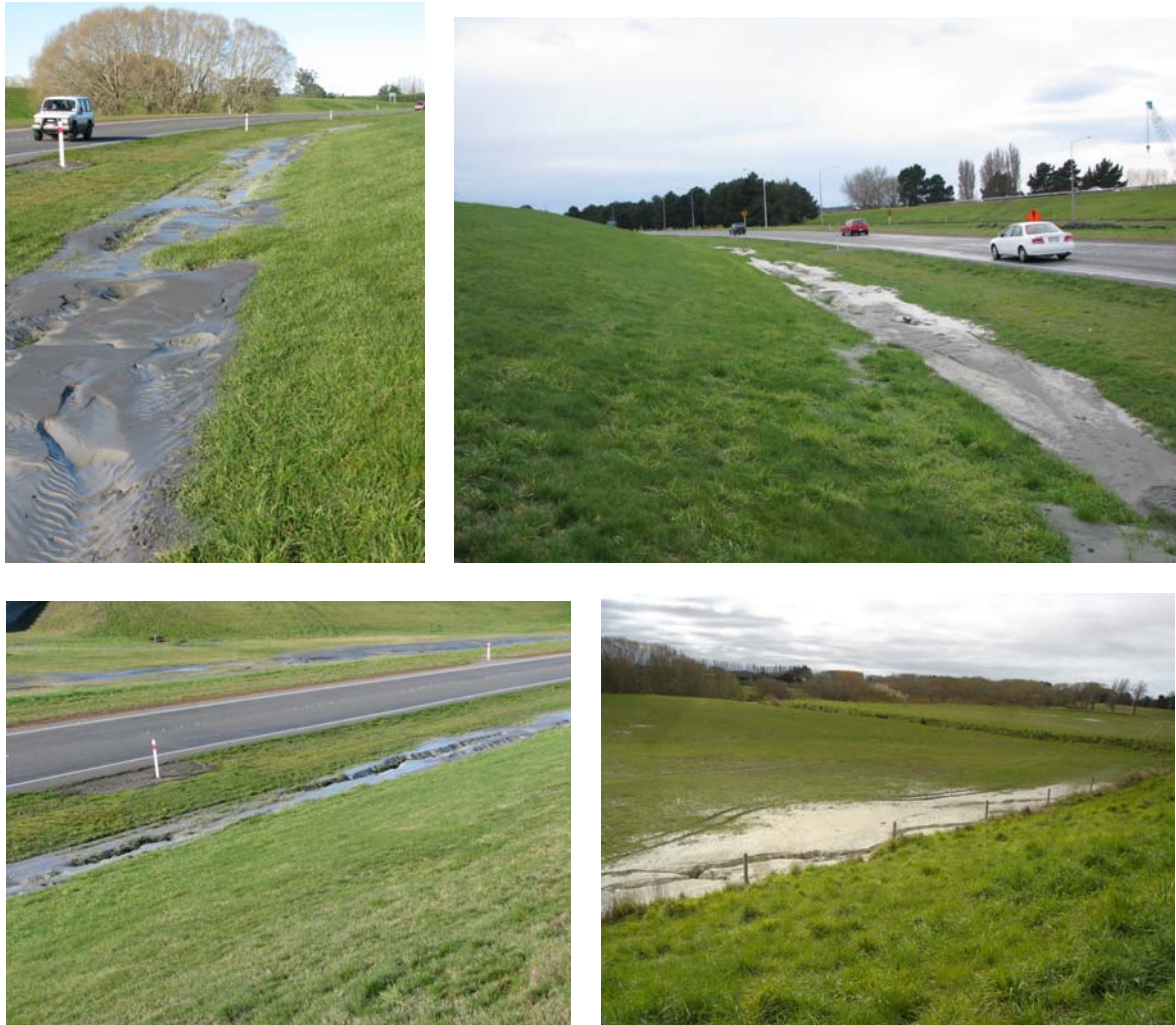
Figure 6.16 Photos 11 and 14: Liquefaction ejecta on both the river and landsides of the stopbank. (43.428968°S, 172.645435°E)

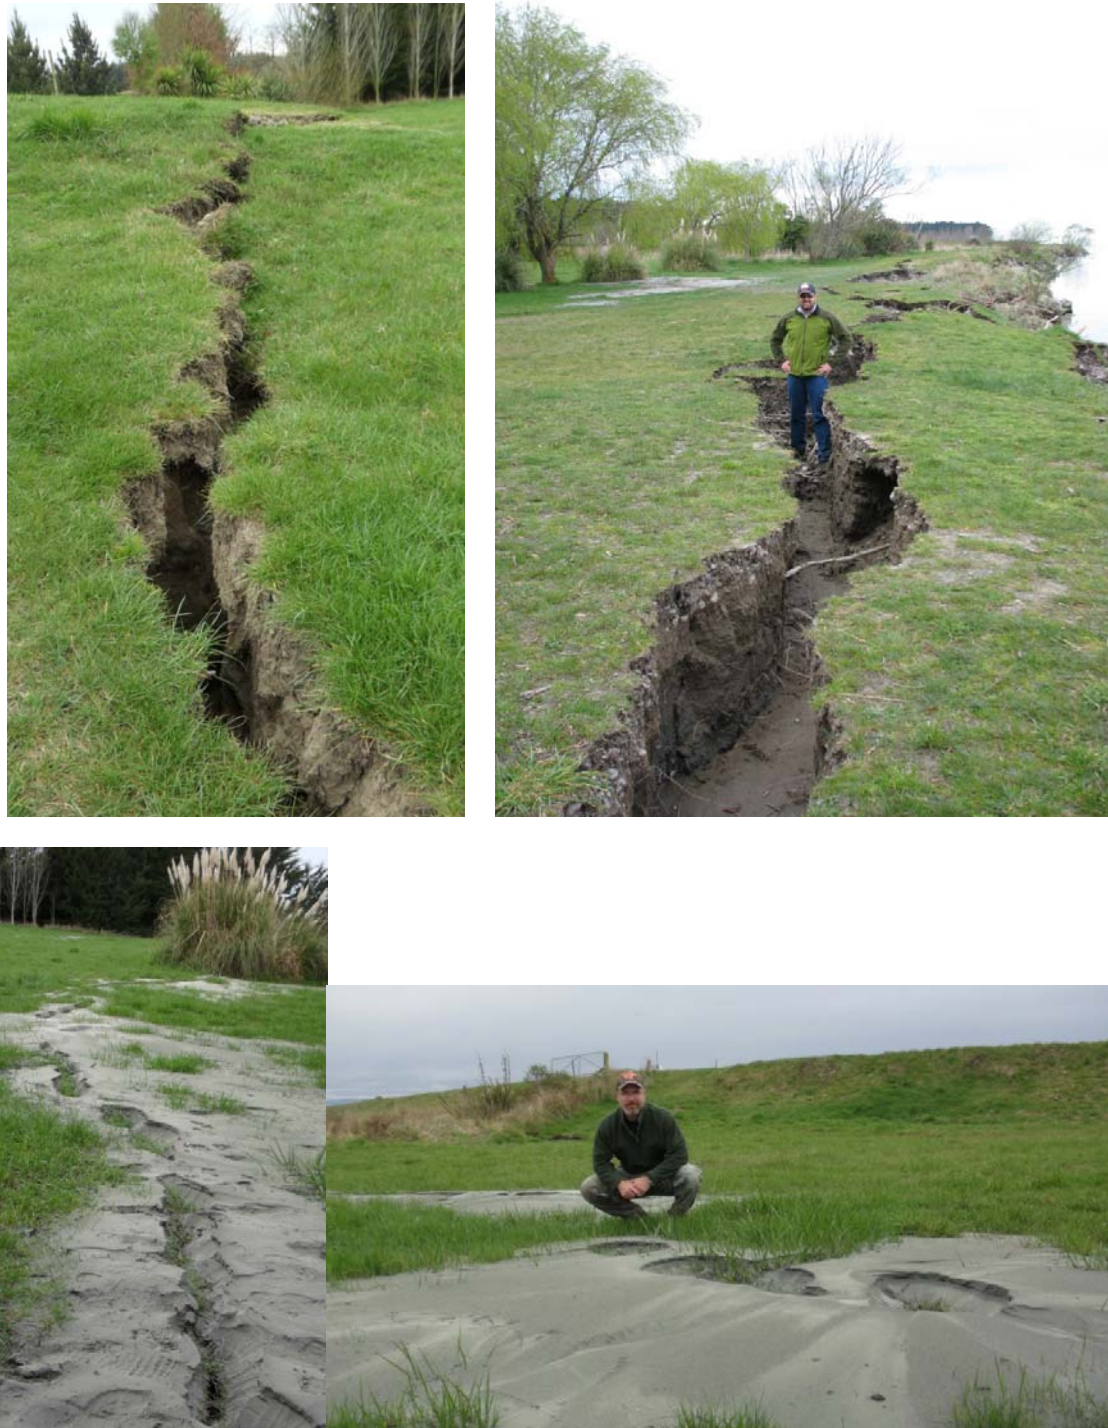
Figure 6.28 Liquefaction and lateral spread features on or near stopbanks located about 100 to 200 m west of the Kaiapoi Sewage Treatment Plant. (upper left: 43.389175°S, 172.683235°E; upper right: 43.389701°S, 172.683390°E; bottom left: 43.389519°S, 172.682203°E; bottom right: 43.389432°S, 172.6682060°E)

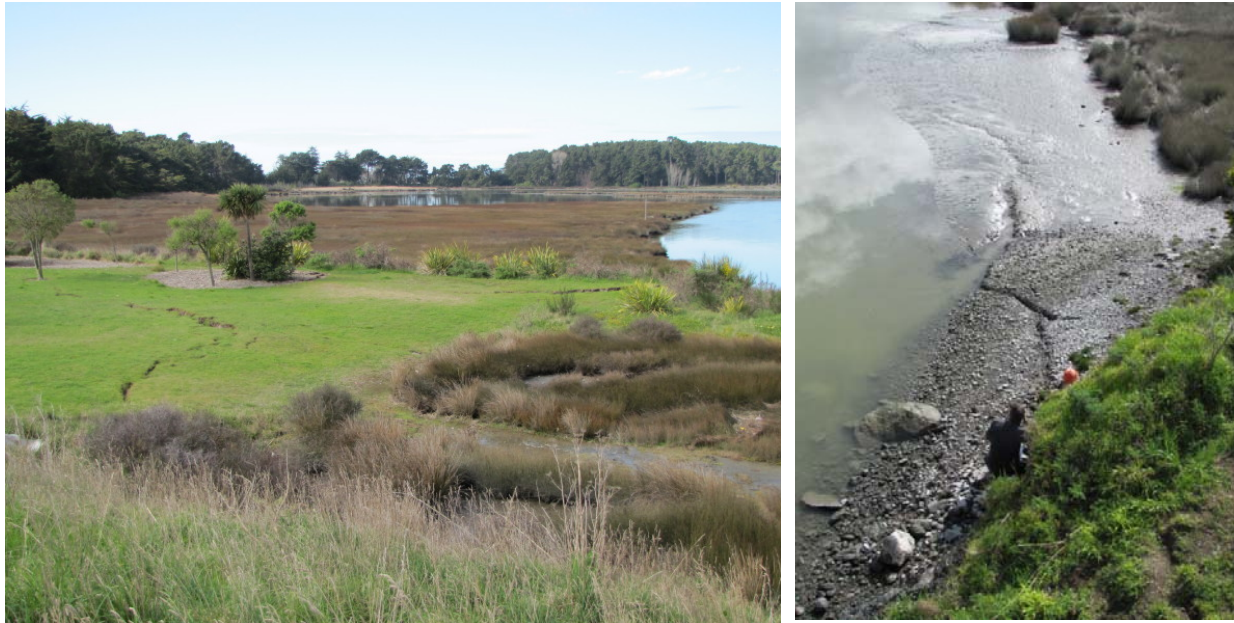
Figure 7.3 Lateral spreading of east banks adjacent to the Bridge Street Bridge

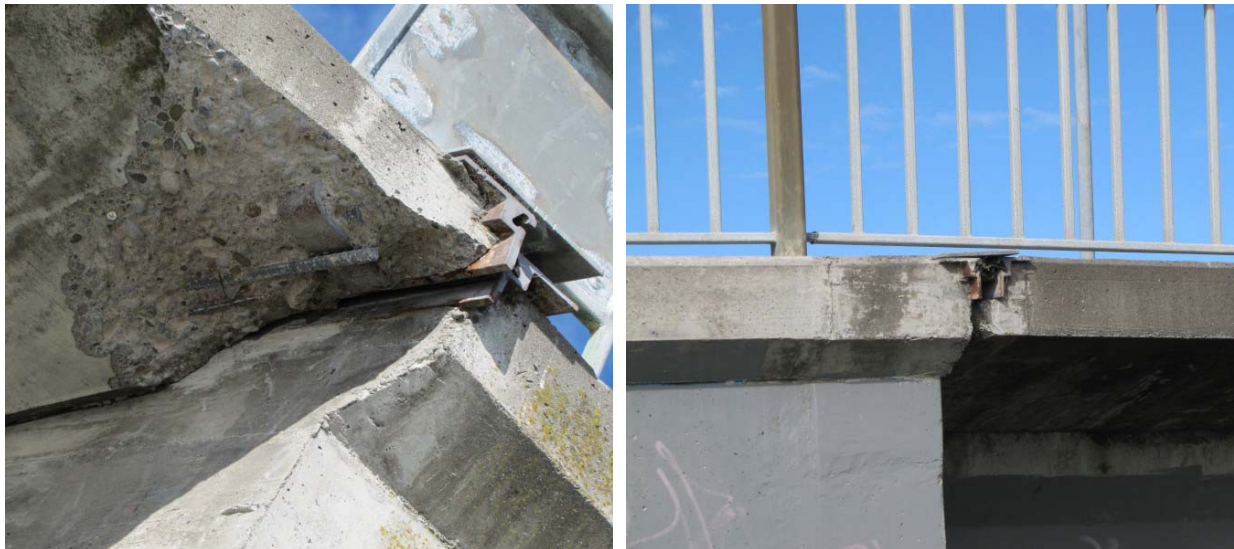
a) West abutment gap closure and spalling

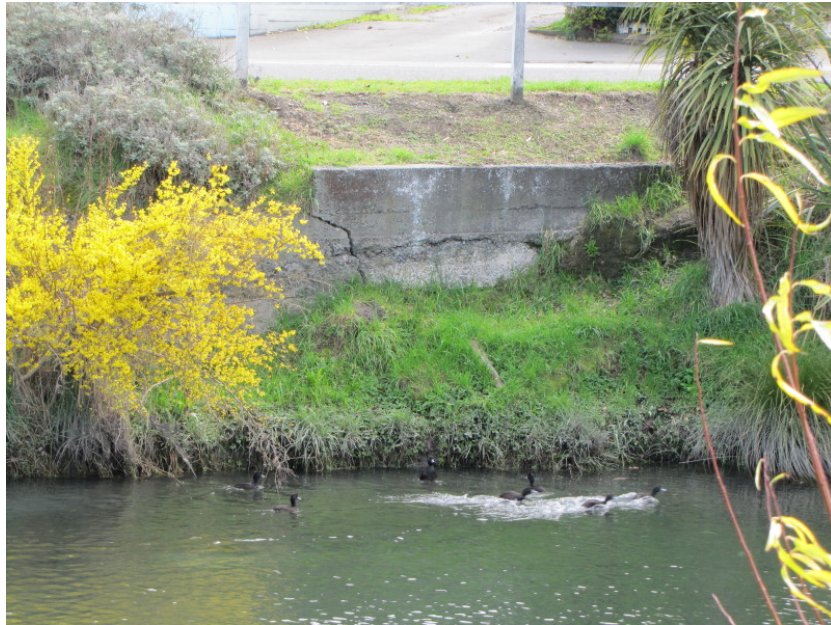
Figure 7.15 Cracking of retaining wall, north bank of the Avon River

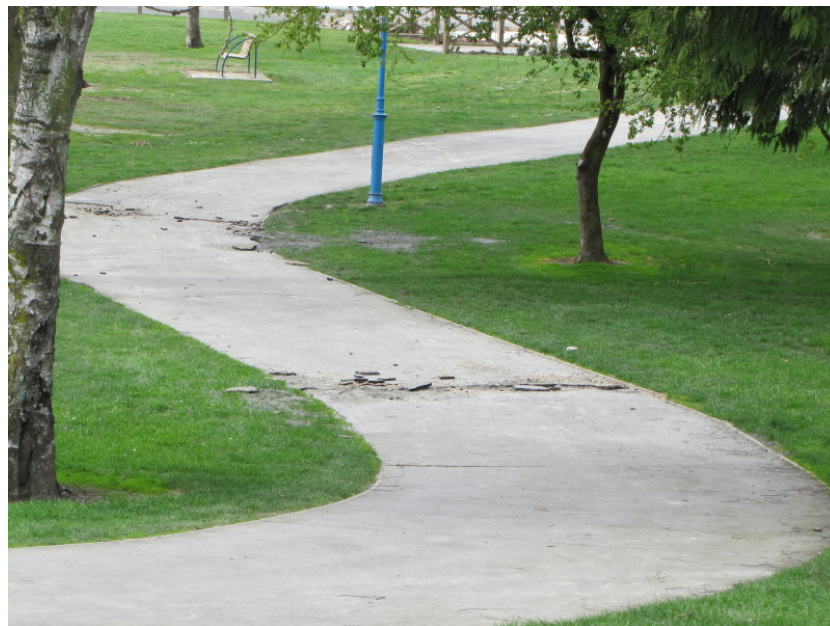
Figure 7.20 Cracking of sidewalk and evience of liquefaction in Trousselot Park

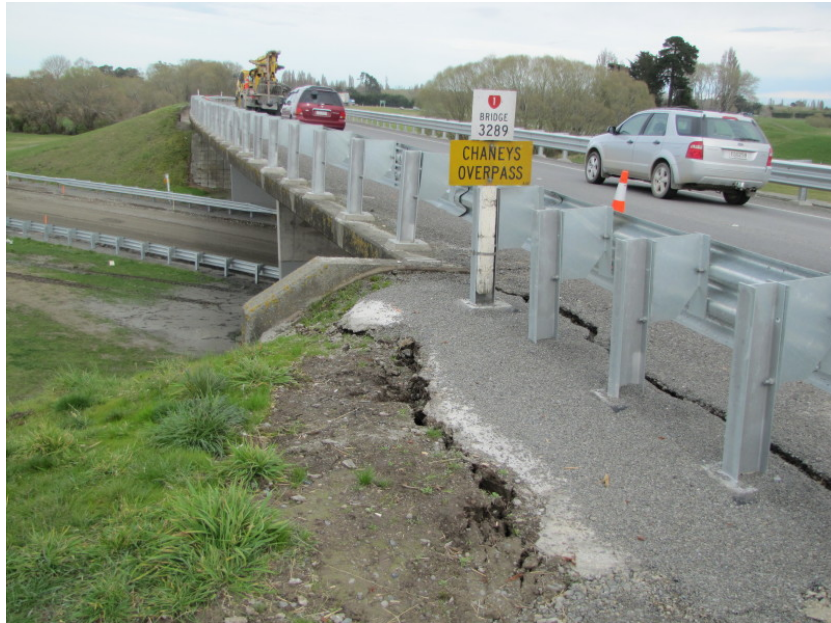
Figure 7.21 Incipient lateral spreading at Chaney's Overpass north abutment

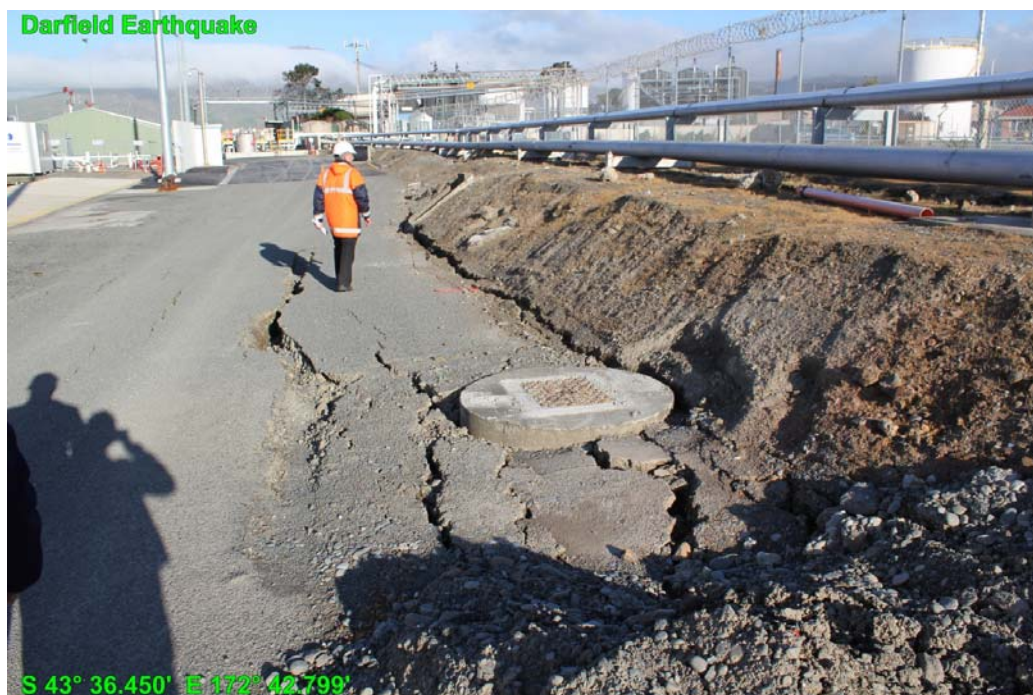
Figure 7.37 Settlement and lateral deformation at fuel transfer facility (43.60750°S, 172.71332°E).

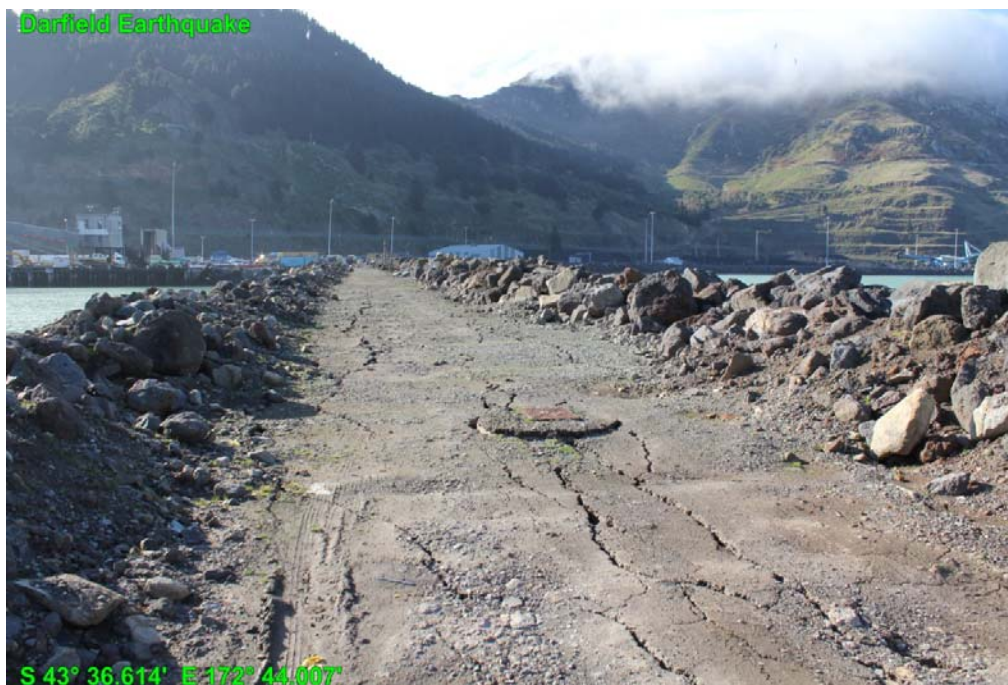
Figure 7.39 Cracking along jetty at eastern end of port (43.61023°S, 172.73345°E).
